# Manhole Inspection Summary

Manhole # S21I\_\_030MH

Insp Date: **9/24/07 12:52 PM**

**Location** Address: **27 FULTON AVE**

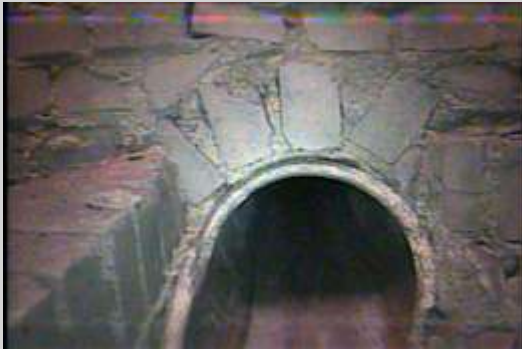
12 O'Clock Outflow

8 in. Circular Gravity Sewer  
Pipe Out @ 12 O'Clock

Pipe Height: **8.4** (in.) Rod and Bar (Angled)  
Pipe Material: **Clay** ☐ Pipe Lined  
Invert Depth: **9.93** (ft.) Flow Characteristics: **Slow**  
Deposits: ☒ None ☐ Mud ☐ Sludge ☐ Debris ☐ Grease  
Silt Depth: (in.) Deposits Extent:  
Infiltration: **None** Pipe Seal Cond: **Sound**

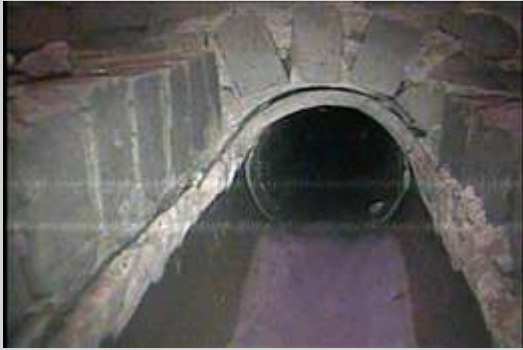
6 O'Clock Inflow

8 in. Circular Gravity Sewer

Pipe In @ 6 O'Clock

Pipe Height: **8.4** (in.) Rod and Bar (Angled)

Pipe Material: **Clay** ☐ Pipe Lined

Infiltration: **None** Pipe Seal Cond: **Sound**
